# Manhole Inspection Summary

Manhole # S29MM1078MH

**Location** Address: **4403 SEDGWICK RD**

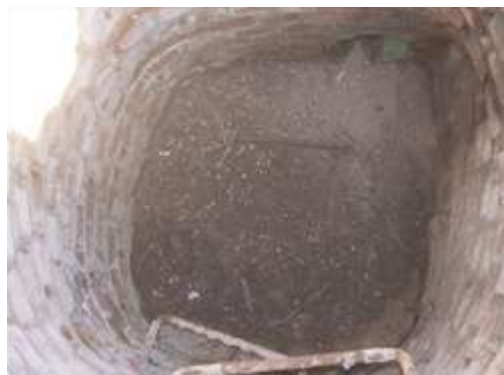
Top View

Channel debris.

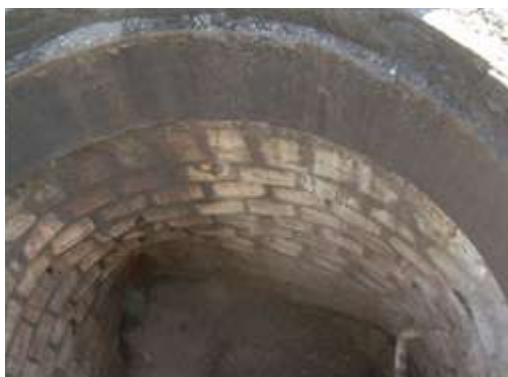
Defect

☒ **Leaks**

Infiltration: ☐ None ☒ **Joint** ☐ Cracks ☐ Mortar ☐ Roots ☒ **Wall**

Infiltration: ☐ None ☐ Joint ☐ Cracks ☒ **Mortar** ☐ Roots ☒ **Wall**

Frame leaks. Adjustment and Barrel infiltration.

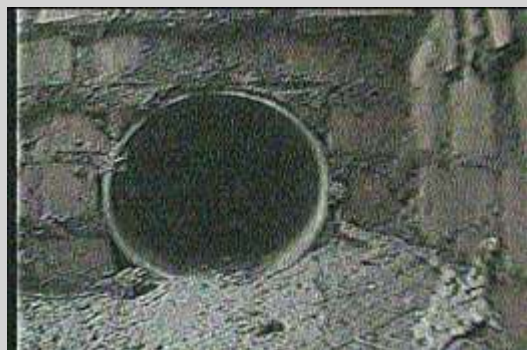
Pipe Out @ 12 O'Clock

Deposits: ☐ None ☒ **Mud** ☐ Sludge ☒ **Debris** ☐ Grease

Silt Depth: **0.5** (in.)

Deposits Extent: **Light**
